Historical Investigation Locations
 Upper Valley Regional Landfill Corporation
 7412 VT Route 113
 Thetford Vermont

7412 VT Route 113
Thetford, VT

Upper Valley Regional Landfill
Corporation

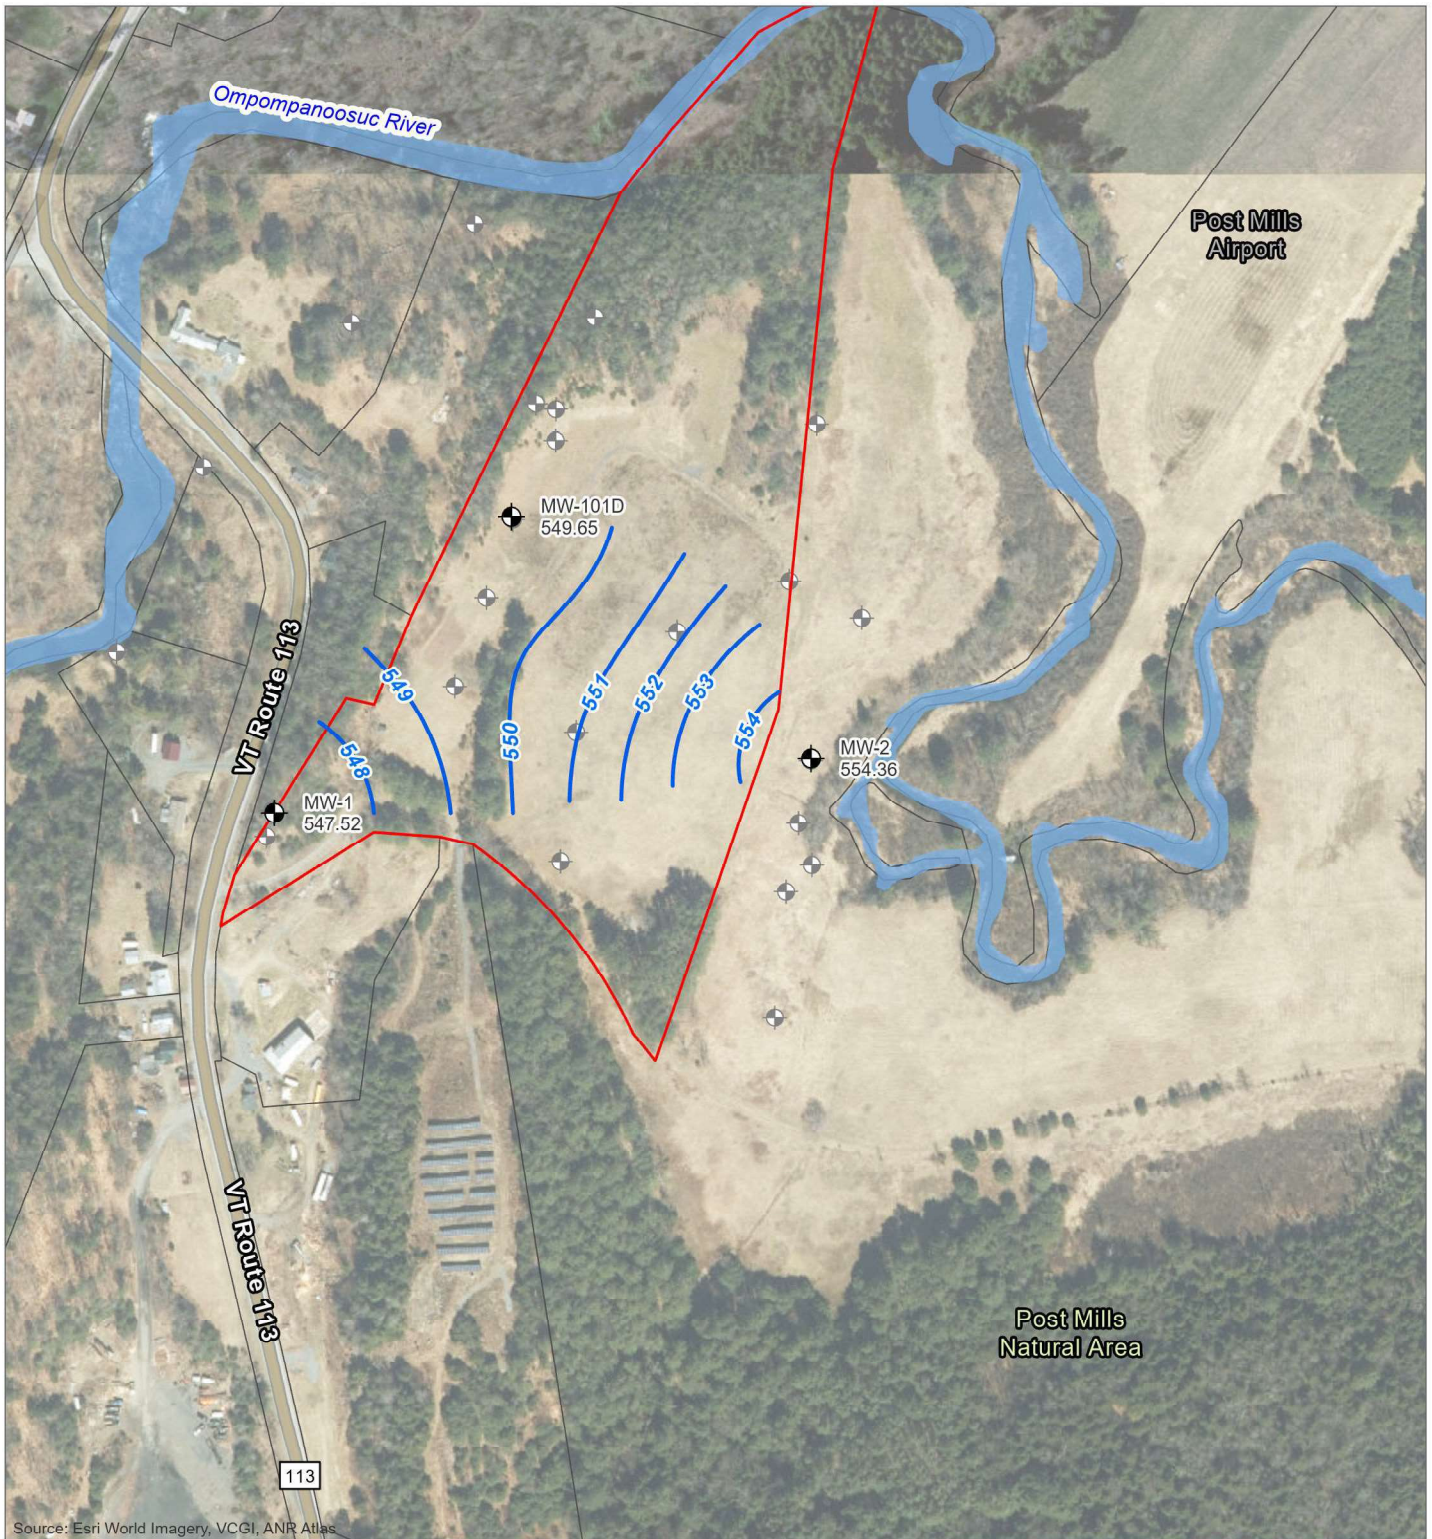
Figure 5: Overburden Potentiometric Surface Map - November 2022

Notes:
Groundwater elevations in ft above mean sea level
Relative casing elevations were obtained from a 1995 report titled "Hydrogeologic Summary of the Upper Valley Regional Landfill in Post Mills, Vermont (Town of Thetford)" prepared by Caswell, Eicher and Hill, Inc.
